COESAM/PDEI-02-005

Intensive Architectural Survey of World War II and Cold War Resources Camp Shelby, Mississippi

Final Report

Brockington and Associates, Inc.
Atlanta Charleston Raleigh
October 2002

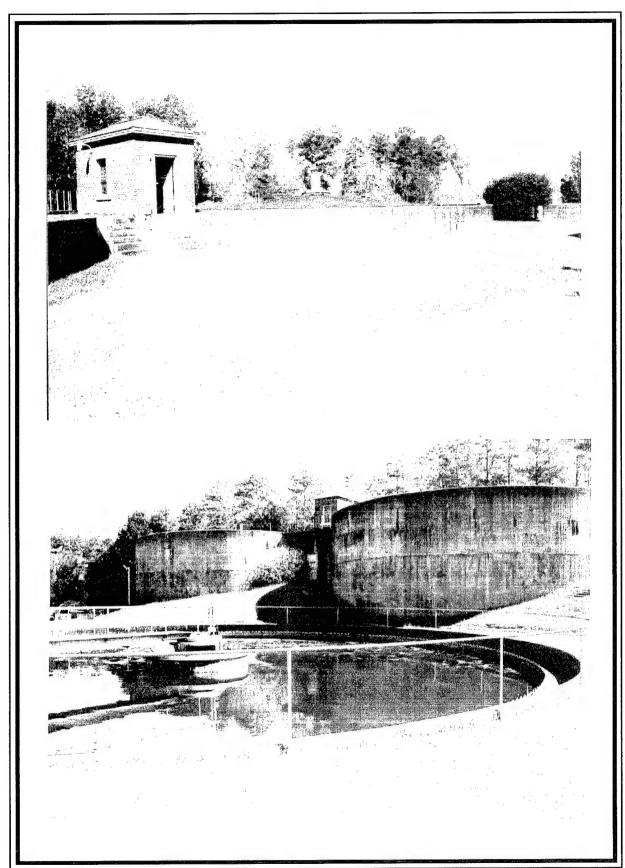
The materials used in the plant include primarily brick and concrete. The three tanks, the base of the drying beds, and the subterranean frame of the clarifiers and aeration basins are constructed of concrete, while the control house and other associated buildings are constructed of brick. The plant uses an "activated sludge" process of sewage treatment, developed in England between 1912 and 1915, which calls for the use of compressed air in a wastewater tank. The air creates increased circulation as well as a higher level of oxygen, and thereby fosters greater biological activity. The result was cleaner water than in earlier methods (Kuranda et al. 1995:184).

Figure 12. Wastewater Treatment Plant No. 1. Top: Building 5592, looking northwest: Bottom: clarifier, looking north.

While there are no direct threats to Wastewater Treatment Plant No. 1, the nature of such facilities requires regular upgrades and alterations. We recommend that the Mississippi National Guard (MNG), in coordination with the Mississippi State Historic Preservation Office (SHPO), develop of a management plan for Wastewater Treatment Plant No. 1 as a historic property. This plan should be flexible, and should include a list of improvements and alterations to the plant that will not require oversight by the SHPO. All changes to the plant should be documented. If the ongoing mission of the MNG will require the demolition of Wastewater Treatment Plant No. 1, we recommend that the MNG develop a mitigation plan in coordination with the SHPO. This mitigation plan should include Historic American Engineering Record (HAER) level documentation of the plant.

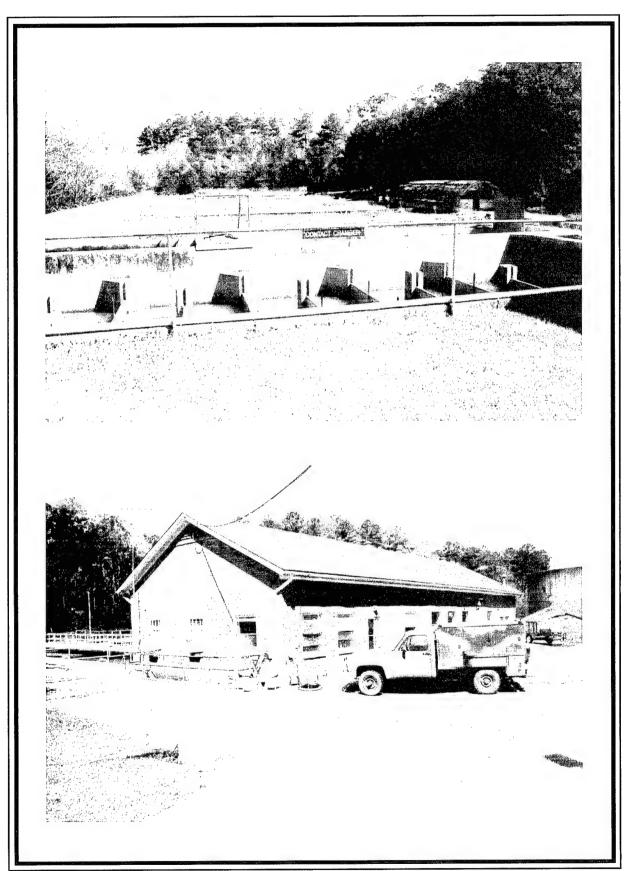
Figure 13. Wastewater Treatment Plant No. 1. Top: drying beds, looking north; Bottom: Building 5590, looking northwest.

The Army built 108 sewage treatment systems during WWII (Kuranda et al. 1995:201). It is unknown how many of these plants are extant, and of these, how many are intact and continue to function. It is unlikely, however, that many have retained a similar level of integrity and condition. None are known to exist in Mississippi. Wastewater treatment plants were vital to the successful operation of a military training facility, particularly one on the scale of Camp Shelby during WWII. In this sense, wastewater treatment plants are vital to the mission of a primary training facility. We recommend Wastewater Treatment Plant No. 1 eligible for the NRHP under Criteria A (Military) and C (Engineering).

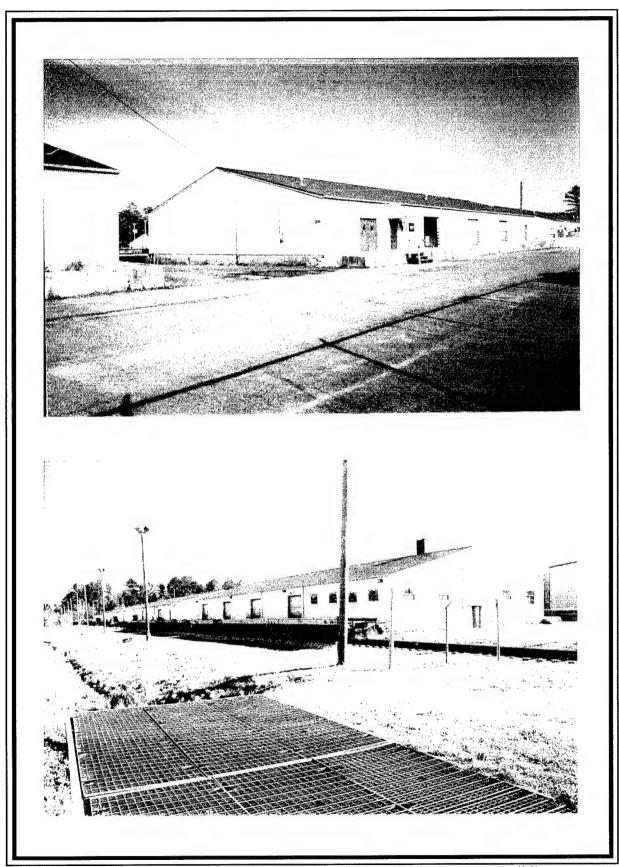
Each of the thirteen warehouses is a one-story frame building with corrugated metal siding, and is raised approximately three feet above the ground on a concrete foundation. The roofs are clad in modern composition shingles. The warehouses typically contain two types of doors: single metal doors beneath corrugated metal awnings, and metal roll-type single garage doors. The windows are primarily multi-pane industrial windows. Figure 15 presents views of representative warehouses.

Figure 15. Warehouses. Top: Building 6555, looking northeast; Bottom: Buildings 6556-6553, looking southeast.

years with new doors, occasional new windows, and new roofs. In addition, while they were important to Camp Shelby's mission, they are not associated with any historically significant events or developments either in a military or an architectural context. We recommend the 13 warehouses at Camp Shelby (Buildings 6509, 6510, 6518, 6519, 6520, 6553, 6554, 6555, 6556, 6631, 6632, 6633, and 6634) not eligible for the NRHP.

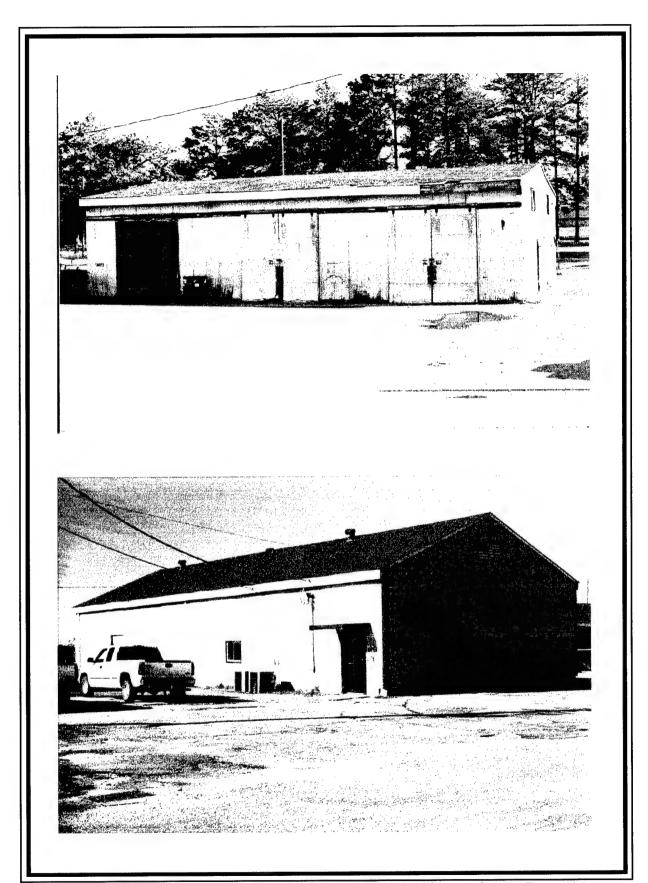
Apparently, Building 6517 is in original condition. It is clad in corrugated metal siding, with an old composition shingle roof. The long side features three double garage doors that slide open on top rollers. One narrow end features two small windows in the gable, while the other narrow end has no openings. Figure 17 (top) presents a view of Building 6517. Building 6684 was built according to the same plan, but its exterior has been reclad. The walls are now clad in asbestos shingles, while the roof is clad in modern composition shingles. There is now a single door on the long side of the building. Figure 17 (bottom) presents a view of Building 6684.

Figure 17. Maintenance facilities. Top: Building 6517, looking northwest; Bottom: Building 6684, looking northeast.

Even though Building 6517 has retained good integrity, both of the WWII maintenance facilities that remain at Camp Shelby lack additional historical or architectural significance. These are standardized buildings, one of which has been altered over the years with new doors, new windows, and new roofs. In addition, while both were important to Camp Shelby's mission, they had only a supportive role and are not associated with any historically significant events or developments either in a military or an architectural context. We recommend the two maintenance facilities at Camp Shelby (Buildings 6517 and 6684) not eligible for the NRHP.

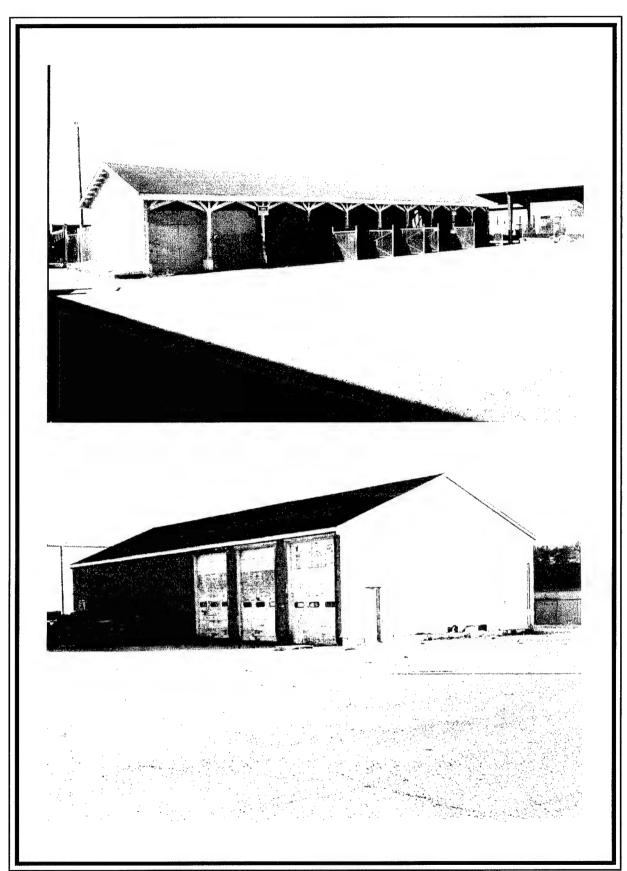
Building 6681 is a long narrow low frame building resting directly on the concrete parking area. The long side is open with ten bays divided by narrow wood piers, each of which is supported by diagonal brackets. The enclosed sides of the building are clad in

Figure 18. Garages. Top: Building 6559, looking northeast; Bottom: Building 6681, looking northeast.

asbestos shingle siding, while the roof is clad in modern composition shingles. Figure 18 (bottom) presents a view of Building 6681.

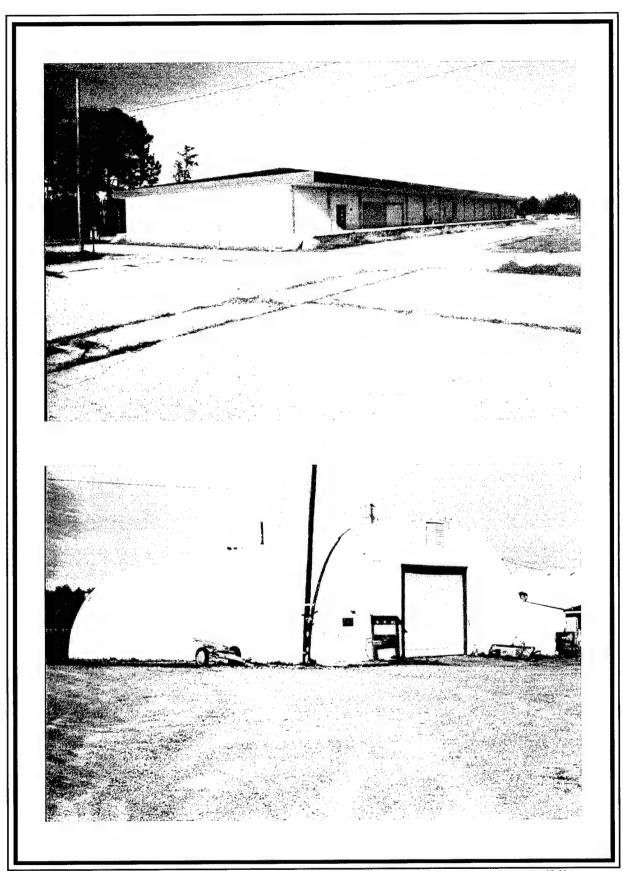
Buildings 6642 and 6890 retain fair to good integrity. Despite their unique appearances, however, both of the storage facilities which are included in the intensive architectural survey lack historical or architectural significance. These are standardized buildings that have been altered over the years with new doors, new windows, and new roofs. In addition, while both were important to Camp Shelby's mission, they had only a supportive role and are not associated with any historically significant events or developments either in a military or an architectural context. We recommend the two storage facilities at Camp Shelby (Buildings 6642 and 6890) not eligible for the NRHP.

Figure 19. Storage facilities. Top: Building 6890, looking northeast; Bottom: Building 6642, looking northwest.

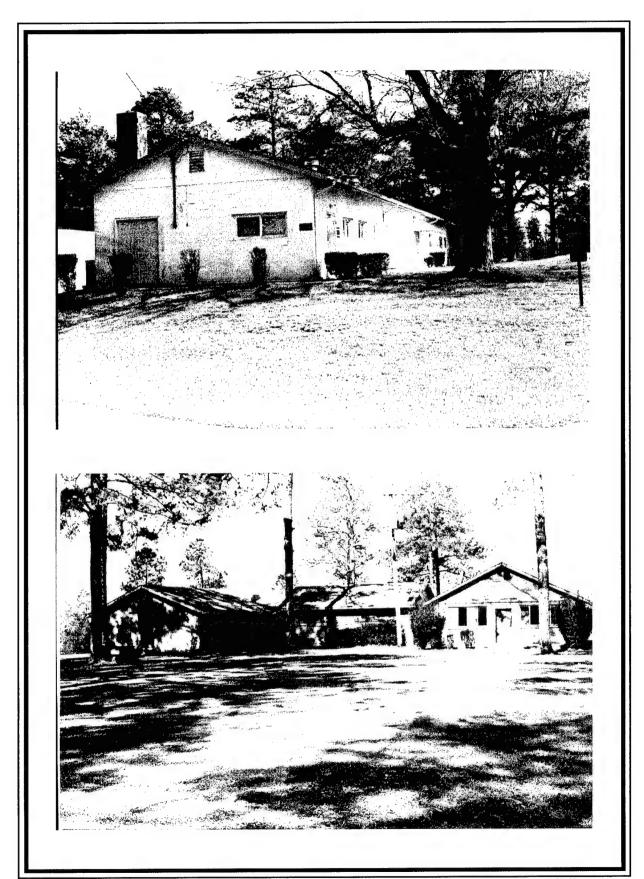
Building 976 is an H-shaped complex built in 1954. The building is constructed of concrete block walls surmounted by a cross gable roof clad in modern composition shingles. The complex consists of two long rectangular front-gabled buildings with a short side-gabled

Figure 20. Residential buildings. Top: Building 900, looking north; Bottom: Building 976, looking northwest.

building between them; the three parts are connected by enclosed walkways. The facades of the two long buildings are symmetrical. One features a central single door flanked on each side by a four-part window, each with a single modern pane; the other contains only a central single door. The cross building features narrow multiple windows beneath the eave. Figure 20 (bottom) presents a view of Building 976.

Both residential buildings retain good integrity. However, both of the residences included in the intensive architectural survey lack historical or architectural significance. Both buildings had only a supportive role and are not associated with any historically significant events or developments either in a military or an architectural context. We recommend the two residences at Camp Shelby (Buildings 900 and 976) not eligible for the NRHP.

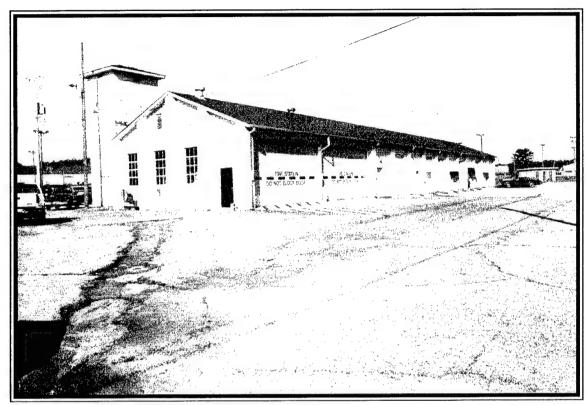
the railroad tracks. The second story of the tower is clad in vinyl siding. Figure 21 presents a view of Building 6521.

Figure 21. Building 6521, looking southwest.

Building 6521 served a unique purpose at Camp Shelby when it was constructed, as the base's only fire station. In addition, the building retains fair to good integrity. However, Building 6521 lacks historical or architectural significance. While important to the ongoing safety of Camp Shelby, the building is not associated with any historically significant events or developments either in a military or an architectural context. We recommend Building 6521 not eligible for the NRHP.

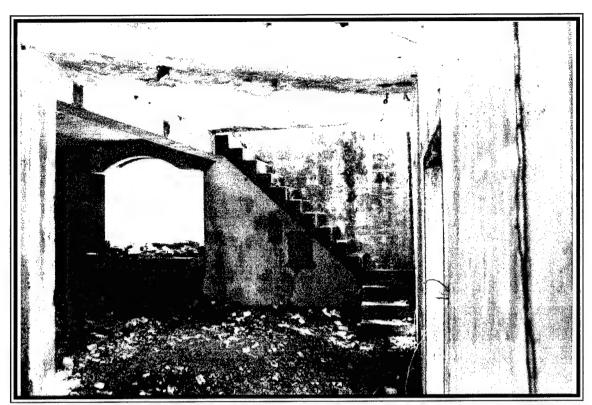
The three incinerators are now abandoned, and two of them are largely deteriorated and overgrown with vegetation. However, one remains nearly intact and accessible. The incinerator is located on sloping ground off the road. It is constructed of concrete. The roof lies just above the grade at the top of the slope, with square openings in the top. The bulk of the incinerator is built into the slope, and access to the lower level is gained by walking down the slope. The lower section is largely open, with a staircase along one wall providing access to the upper level. Figure 23 provides a view of the interior of the incinerator.

The incinerator at Camp Shelby is a distinctive structure, and clearly served a vital purpose to the ongoing health and safety of the camp. However, the incinerator is in fair to poor condition; moreover, its integrity of setting is compromised, as it was designed to be

Figure 23. Incinerator, interior detail.

a part of a complex. The remaining structures that formed the complex are largely deteriorated. Little remains of the original incinerator complex. Despite its interest, we recommend the incinerator at Camp Shelby not eligible for the NRHP.

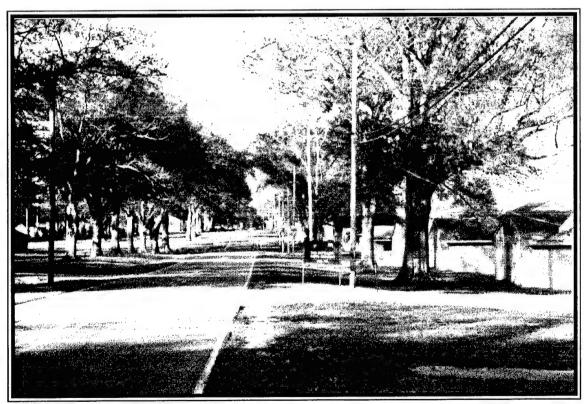
One other landscape element is still extant in the residential area. Jackson Avenue West, which extends southwest from the "White House," contains a row of buildings that were built for the MNG in the late 1930s. These buildings were surveyed previously, and all buildings were determined not eligible for the NRHP (Goodwin et al. 1993). However, this street also contains a very pleasant grove of oak trees. A single line of trees is present along each side of Jackson Avenue West, forming a canopy. While no documentation exists for the trees, it is likely that they were planted in the late 1930s to accompany the new buildings for the MNG. Figure 24 presents a view of Jackson Avenue West showing the grove of oak trees.

Figure 24. Jackson Avenue West, looking north.

This landscape element adds a great deal of visual interest to Camp Shelby, and constitutes one of the most distinctive aspects of the base. While the trees on Jackson Avenue West are important visual elements of the base, they lack additional historical or design significance. We recommend the grove of oak trees on Jackson Avenue West not eligible for the NRHP as a landscape pattern.

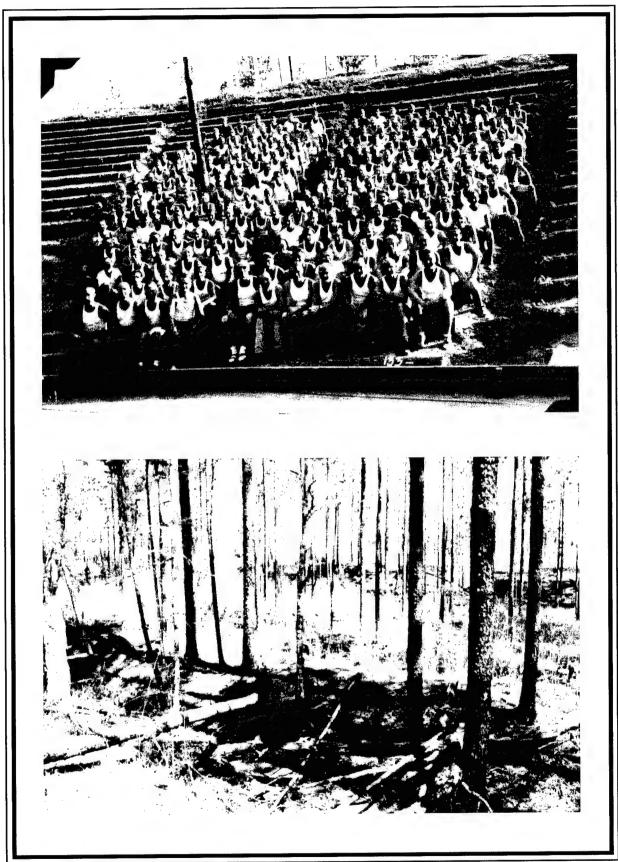
The Architectural Historian conducted a pedestrian inspection of the area and studied current maps of Camp Shelby. It is clear that no buildings remain from the POW stockade at Camp Shelby. The only remnant of the POW stockade at Camp Shelby is the landform

Figure 25. POW amphitheater. Top: undated WWII photo showing German POWs in the amphitheater; Bottom: current view of the amphitheater.

that was used as the amphitheater. This is a level area with natural slopes on each side. However, the area is now heavily overgrown with pine trees. Figure 25 (bottom) presents a recent view of the POW amphitheater area. No other landscape elements from the POW stockade remain at Camp Shelby. We recommend the POW stockade area at Camp Shelby not eligible for the NRHP.
